# *CASE STUDIES*

- Bridgets Café
- Artemis Fine Foods
- THFC Academy New Managers Extension
- THFC First Media Centre
- Segro
- Reactive Repairs (Multiple Clients)

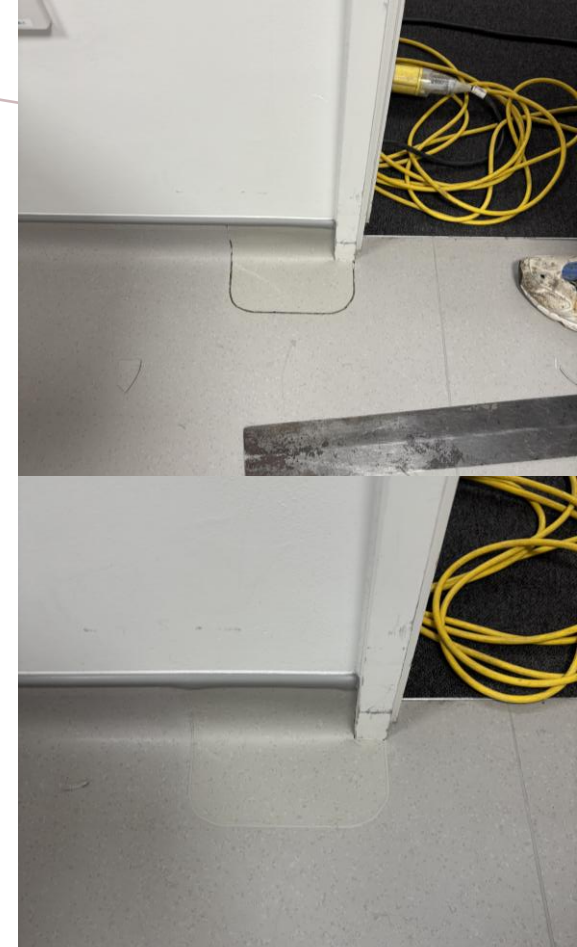
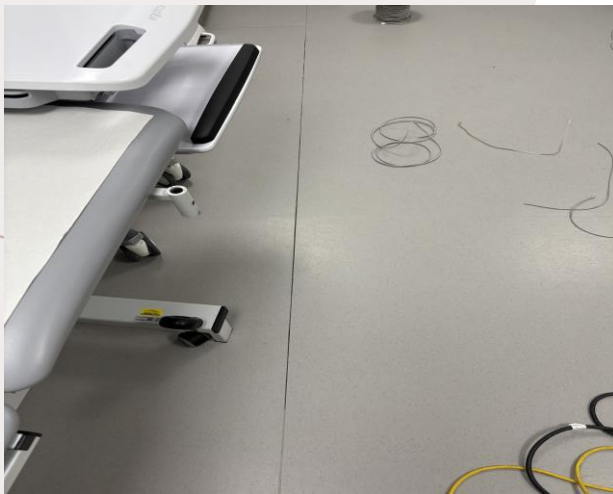
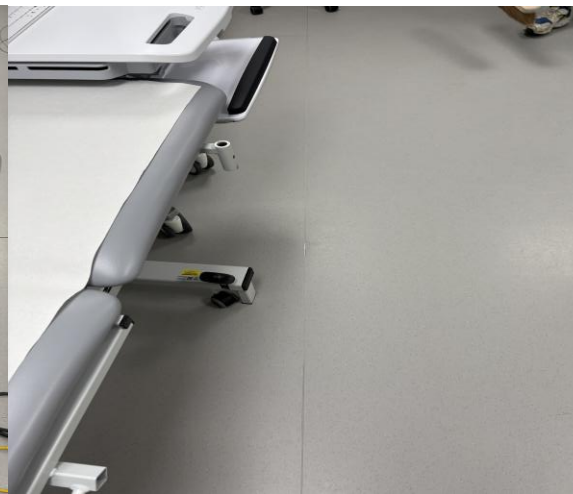
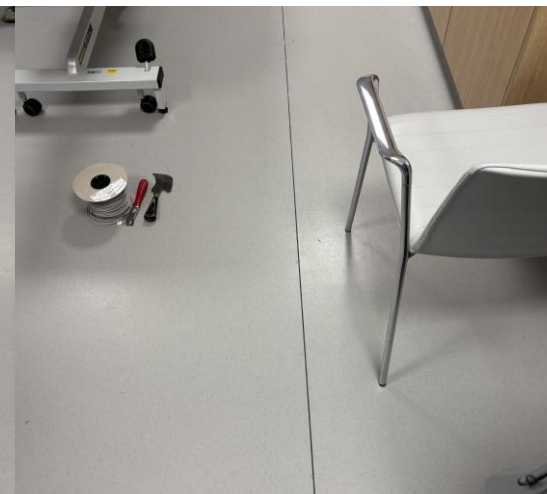
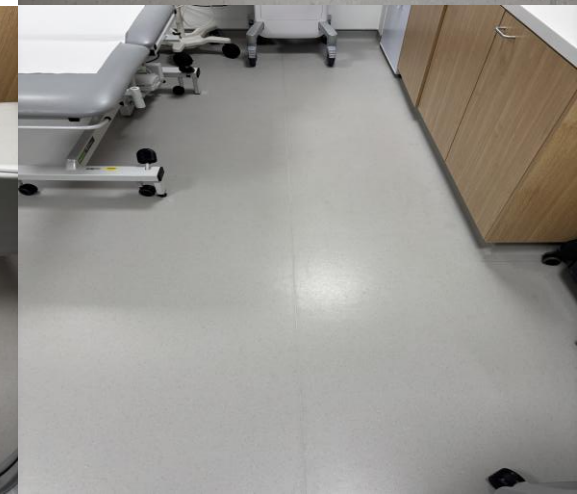
# *CLEVELAND CLINIC GROUP PORTLAND PLACE*

Woodmoore was engaged by the facilities team at The Cleveland Clinic to address flooring defects identified at the end of the main contractor's retention period. The key issues included lifting of Nora rubber flooring in multiple areas, missing welds, raised seams, signs of moisture ingress, and damage to the rubber coving.

- Removing damaged and lifting sections of flooring and replacing them with new Nora sheet rubber.
- Repairing lifted seams by easing them back, applying fresh adhesive, grooving, and finishing with colour-matched Nora rubber weld.
- Restoring damaged coving using Nora Gunseal to deliver a seamless, durable finish.

These works successfully resolved the defects, restoring the flooring to the required standard and ensuring long-term performance.

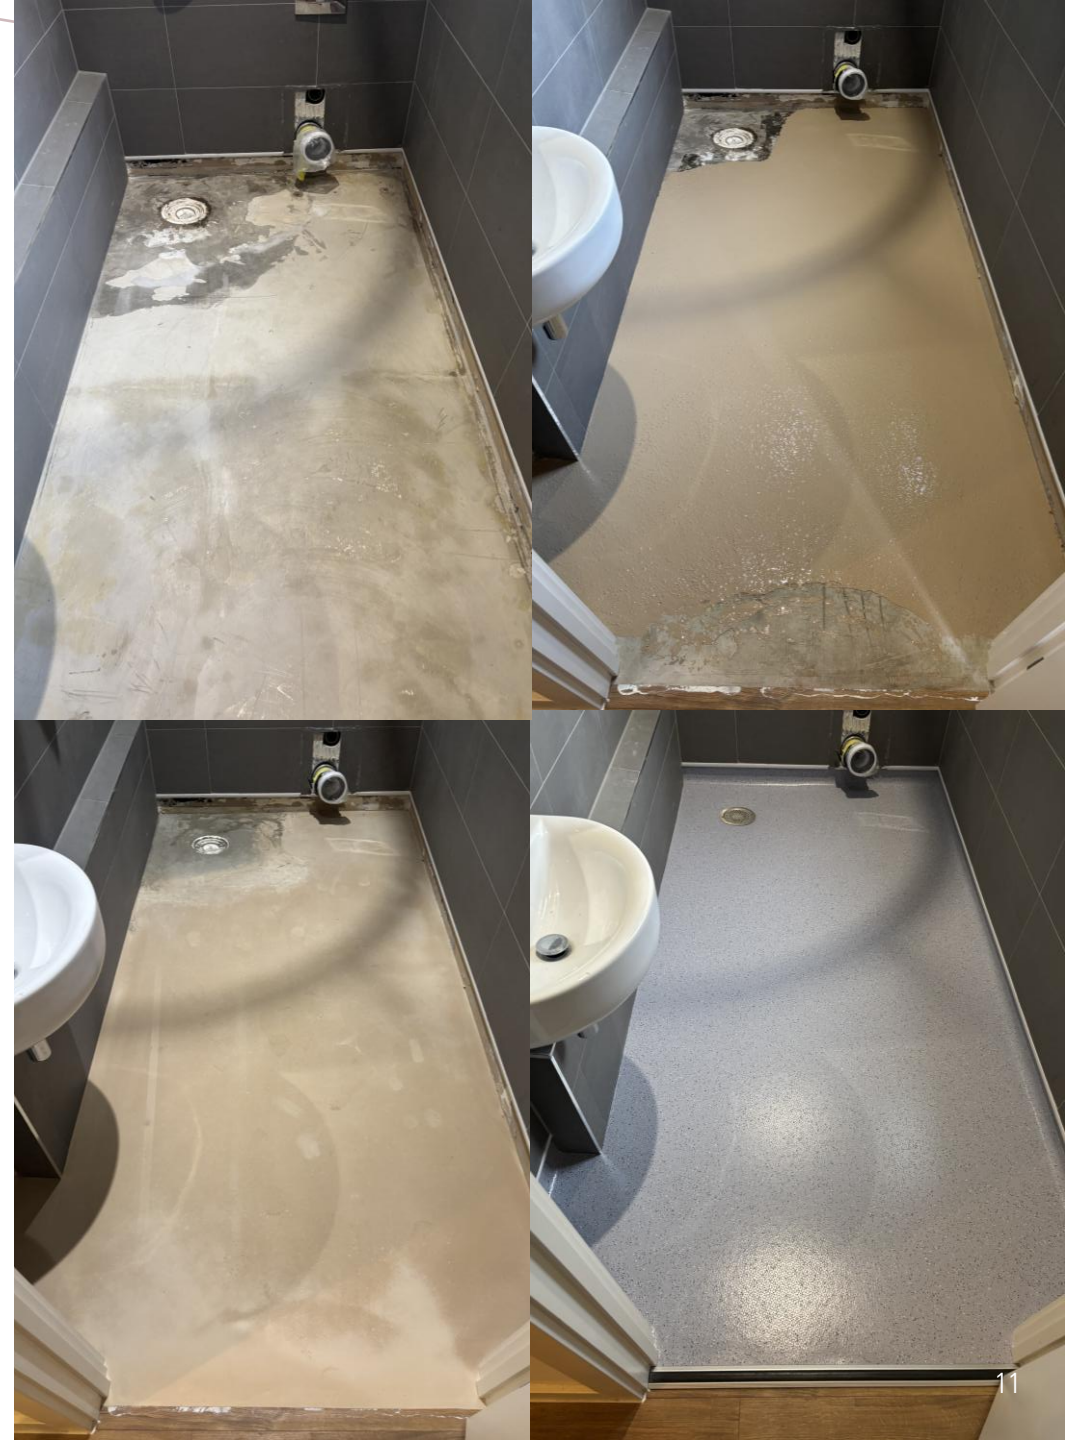
### *GREENWICH RESIDENTIAL DEVELOPMENT-DISABLED BATHROOM FLOOR REMEDIATION*

Woodmoore was appointed to rectify defective shower floors within disabled bathrooms at a new residential development in Greenwich. The original floor gradients had been incorrectly installed, directing water away from the gully rather than towards it. This defect had not been identified by the main contractor or the flooring contractor, necessitating remedial works while tenants remained in occupation.

- Carefully removing the existing vinyl flooring.
- Mechanically stripping residual adhesive and the scratch coat of latex.
- Forming new falls using a moisture-tolerant latex combined with granite aggregate.
- Applying a finishing coat of moisture-tolerant latex to achieve a smooth surface.
- Checking floor levels to ensure effective drainage.
- Installing new Altro Aquarius vinyl for a durable, slip-resistant finish.

The remedial works successfully corrected the gradient issue, ensuring compliant and safe bathroom facilities for residents.

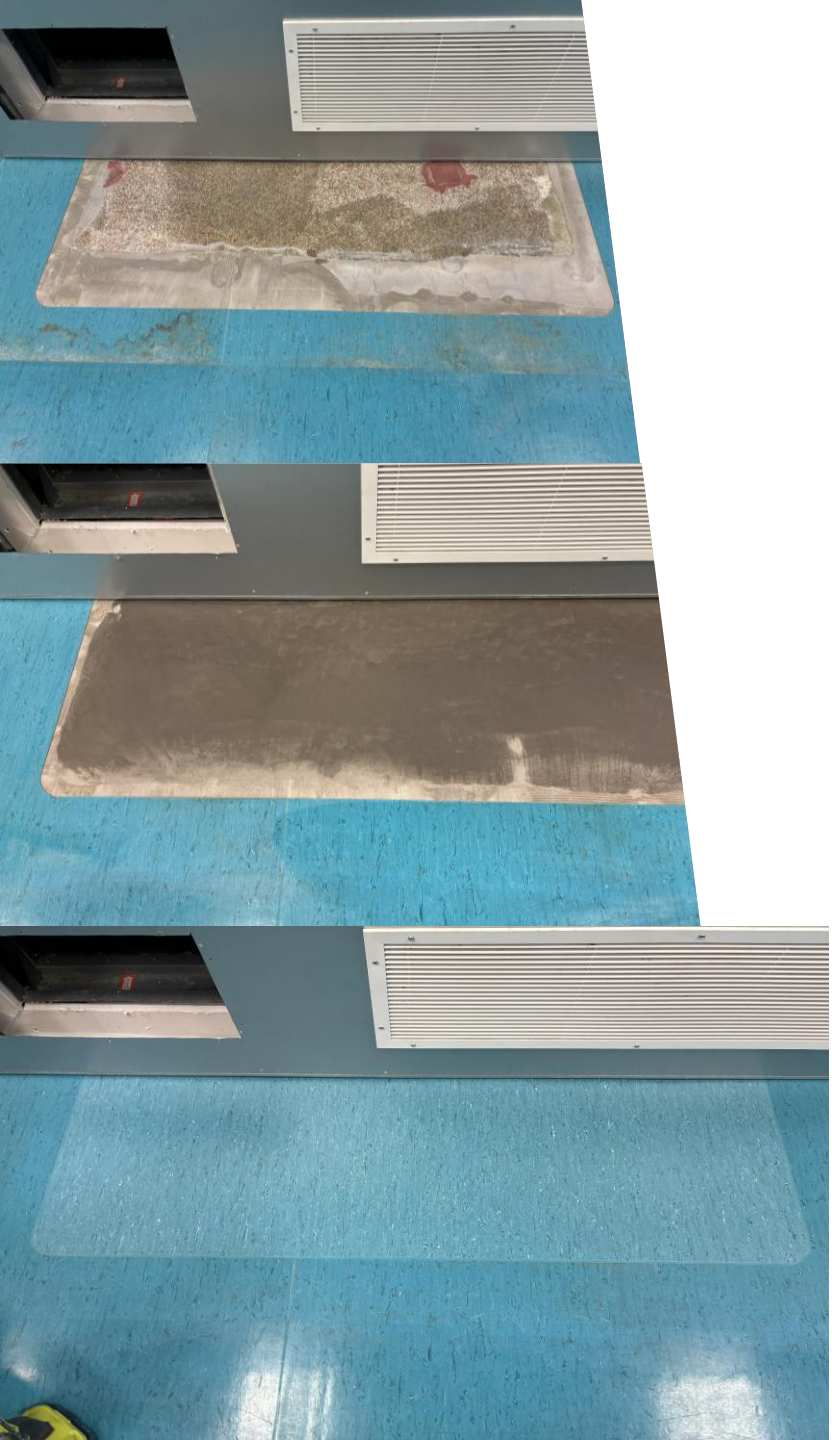
## *ALPINE WORKS –UCL*

Woodmoore was appointed to rectify a patch of flooring that was defective due to poor welding previously undertaken which meant that water got underneath and started making the floor bubble.

- Carefully removing the section of existing vinyl flooring, please note how we round the edges off in order to prevent a broken seal in future use.
- Mechanically stripping residual adhesive and the scratch coat of latex.
- Applying a finishing coat of moisture-tolerant latex to achieve a smooth surface.
- Installing new section of vinyl flooring as close as possible match to the existing flooring routing out the joint and hot welding forming a sealed floor surface.

The remedial works successfully corrected and in a safe manner.

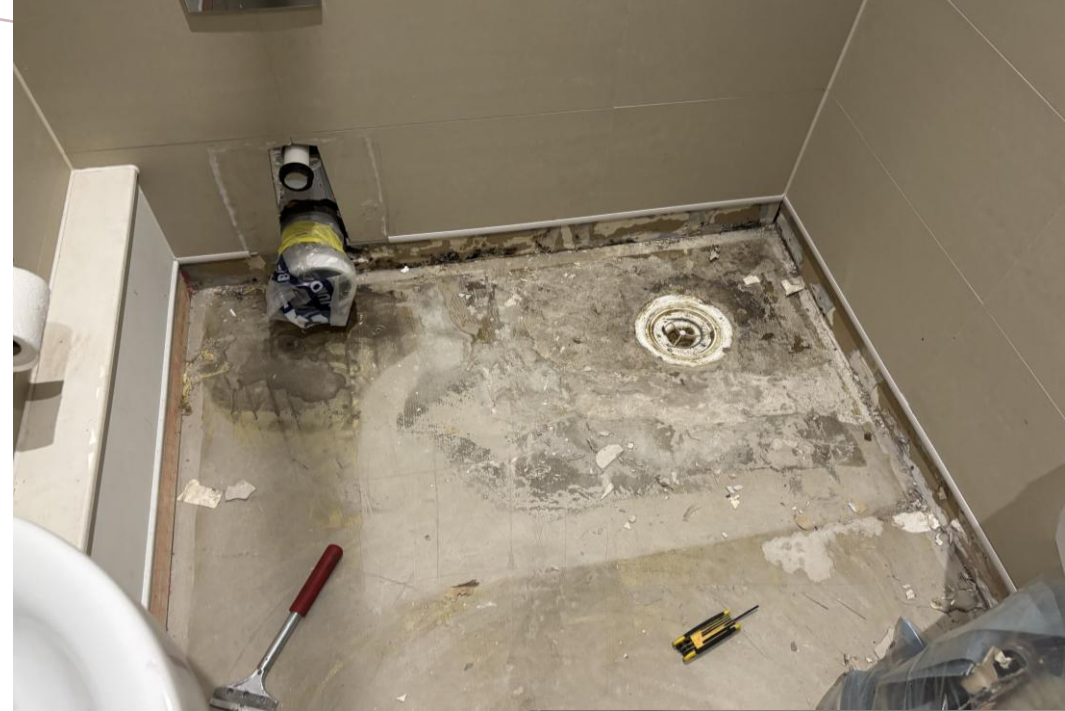
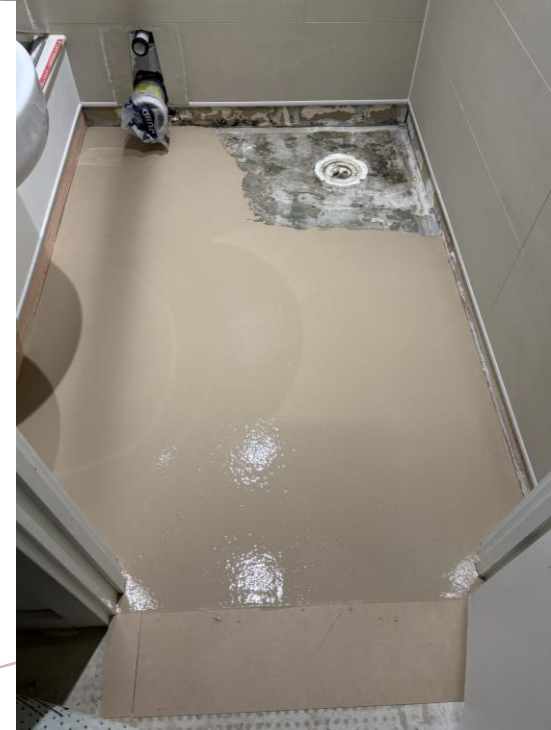
### *NEW UNION CLOSE-DISABLED BATHROOM FLOOR REMEDIATION*

Woodmoore was appointed to rectify defective shower floors within disabled bathrooms at a new residential development in New Union Close. The original floor gradients had been incorrectly installed, directing water away from the gully rather than towards it. This defect had not been identified by the main contractor or the flooring contractor, necessitating remedial works while tenants remained in occupation.

- Carefully removing the existing vinyl flooring.
- Mechanically stripping residual adhesive and the scratch coat of latex.
- Forming new falls using a moisture-tolerant latex combined with granite aggregate.
- Applying a finishing coat of moisture-tolerant latex to achieve a smooth surface.
- Checking floor levels to ensure effective drainage.
- Installing new Altro Aquarius vinyl for a durable, slip-resistant finish.

The remedial works successfully corrected the gradient issue, ensuring compliant and safe bathroom facilities for residents.
